TOPTESTER OY

IP6X DUST TEST

Lumonite Compass (V7)

Test ID: IP6X_Handshake_210601
Report version: 1.0
Class: Cust

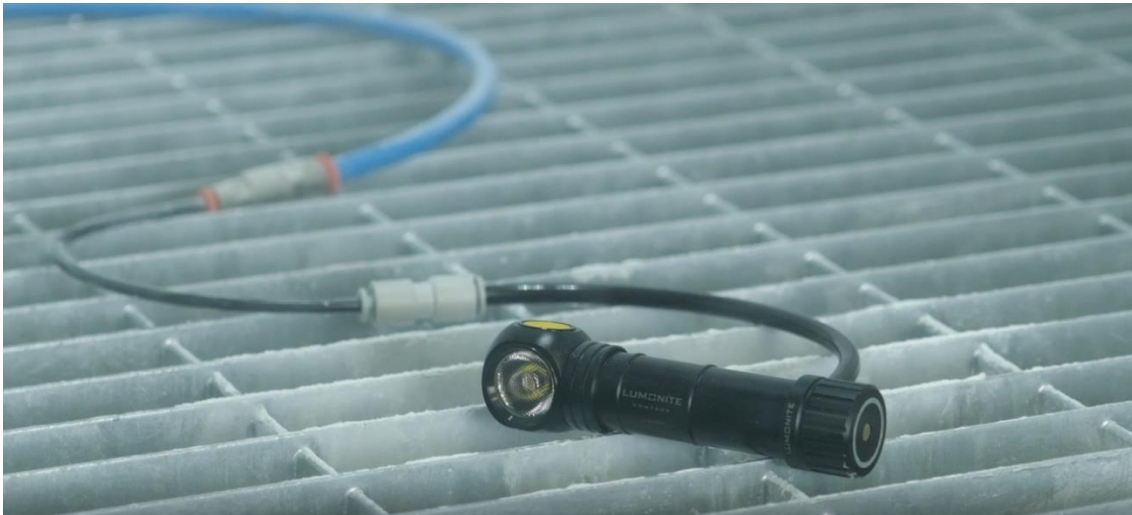
The EUT was placed inside a dust test chamber. Pressure inside the battery case was maintained below the surrounding atmospheric pressure by a vacuum pump. Object was to continue the test until 80 volumes have been drawn through the enclosure, or a period of 8 h had elapsed. The extraction rate was under 40 volumes per hour with maximum pressure of 20 mbar. Duration of the test was 5 hours.

Figure 1. IP6X test setup.

The test was performed with Vötsch VDT 1000 A dust chamber.

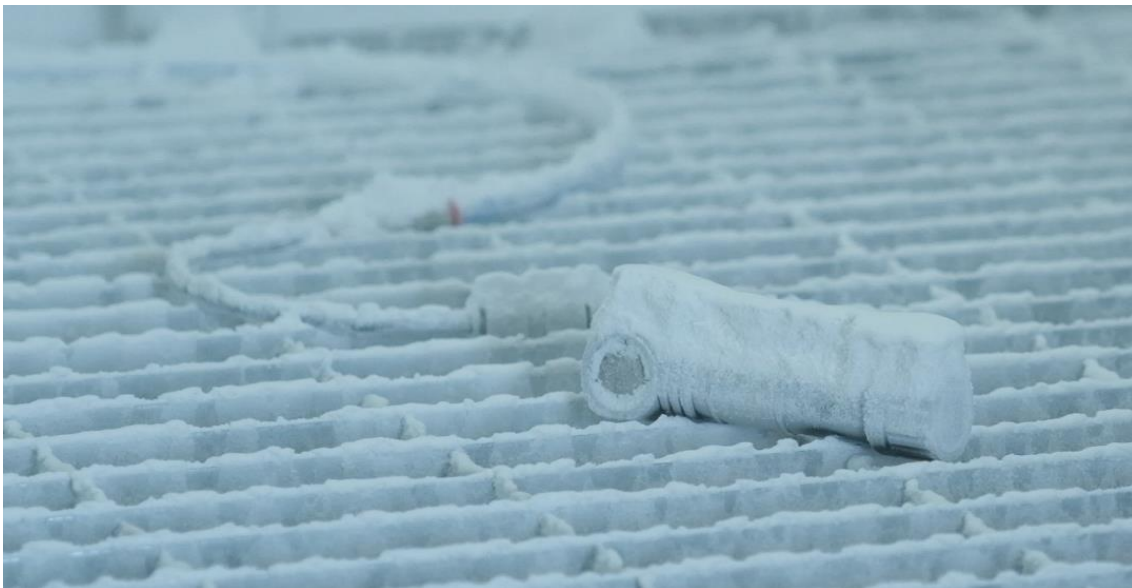
Figure 2. EUT after the test.

After the test, outer surfaces of the EUT were cleaned and the battery case was opened for the inspection. No dust was found inside the enclosure. After inspection, functionality of the EUT was tested. The EUT was operating normally.

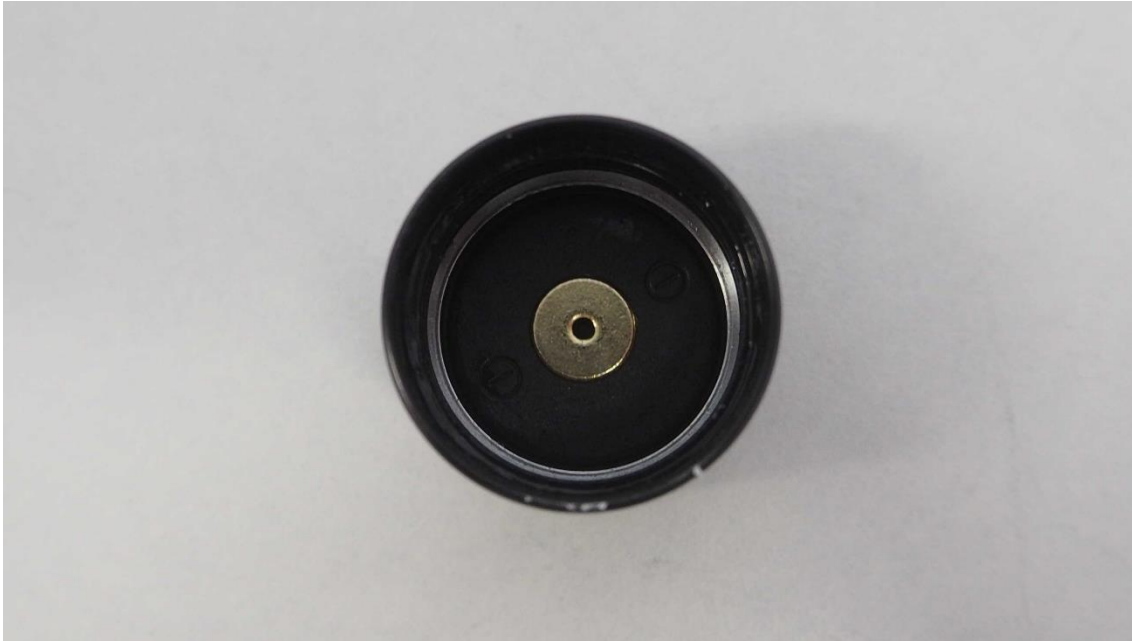
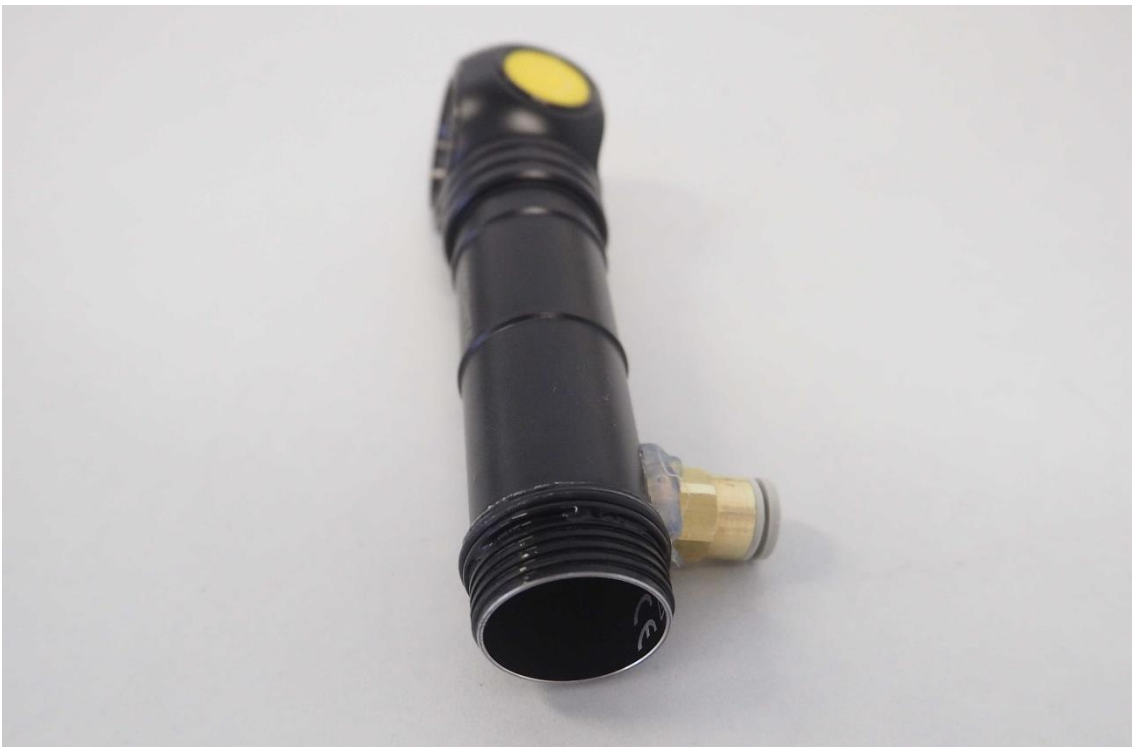
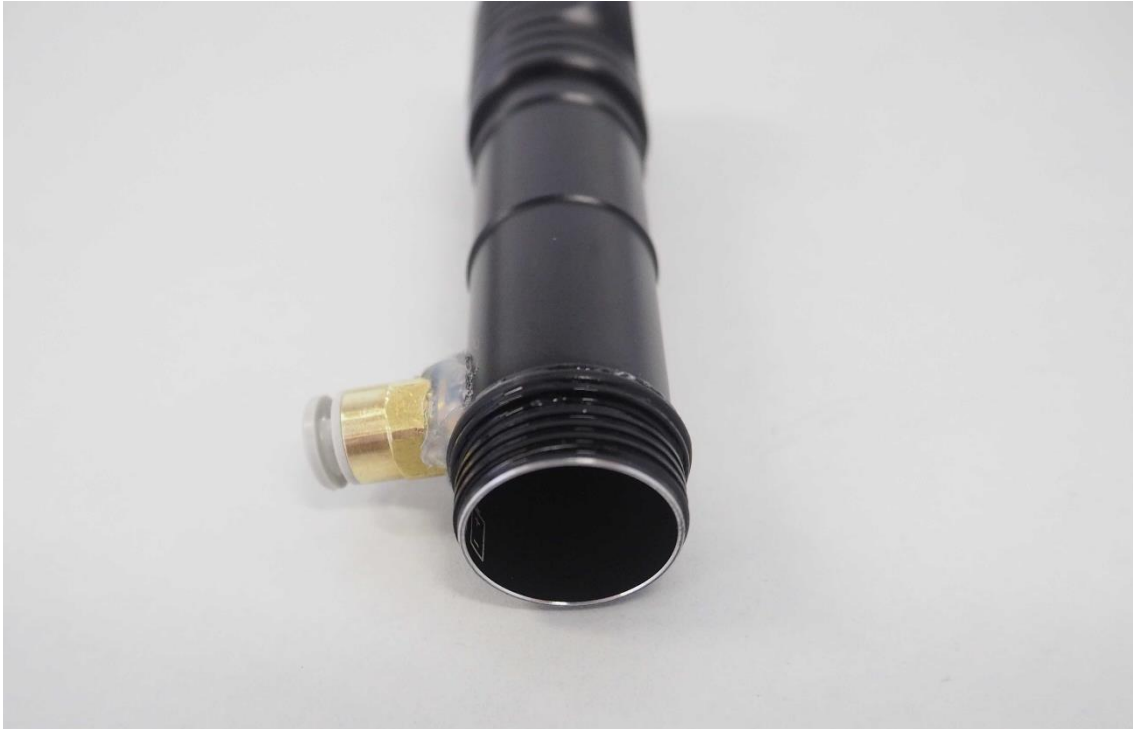
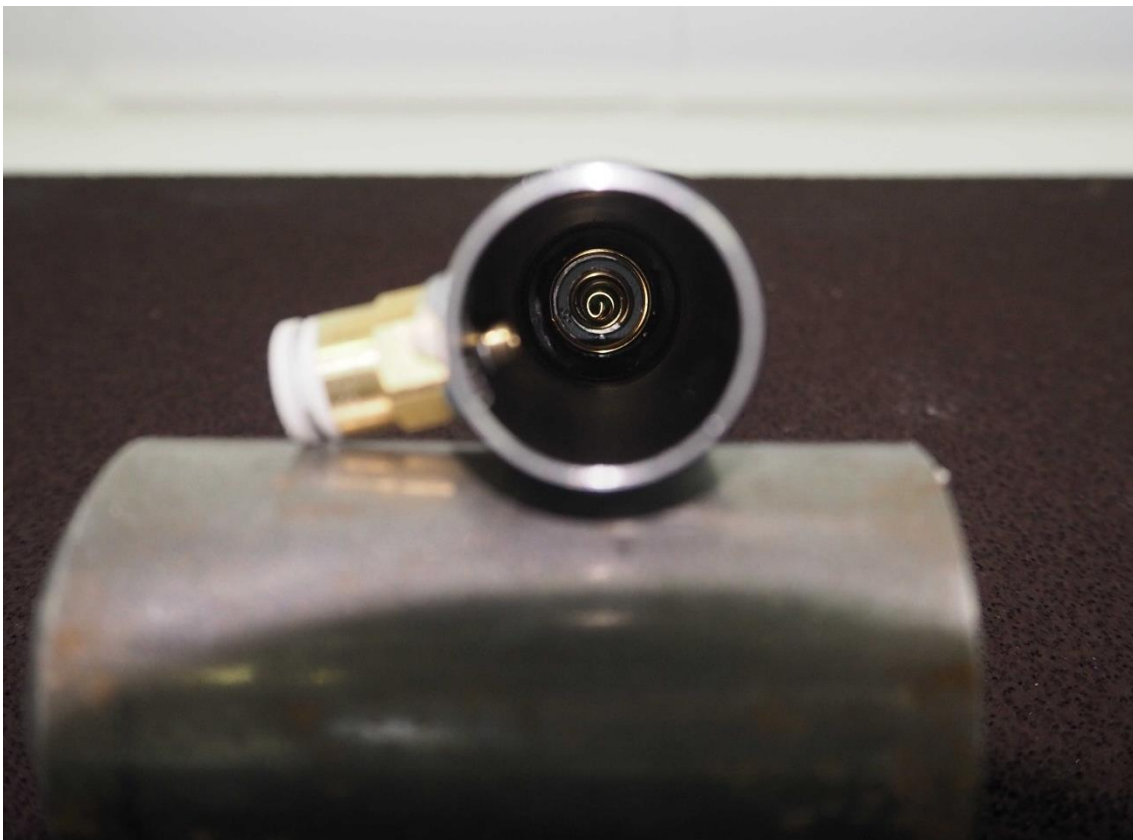
Figure 3. Battery case opened after test.

Figure 4. Battery case opened after test.

Figure 5. Battery case opened after test.

Figure 6. Battery case opened after test.

After the test, no dust was found inside the battery case and the EUT was functioning normally.
IP6X test result is **pass**.
