TEST REPORT

IPX9

Customer: Handshake Finland Oy
Device name (& version): Lumonite Compass (V7)

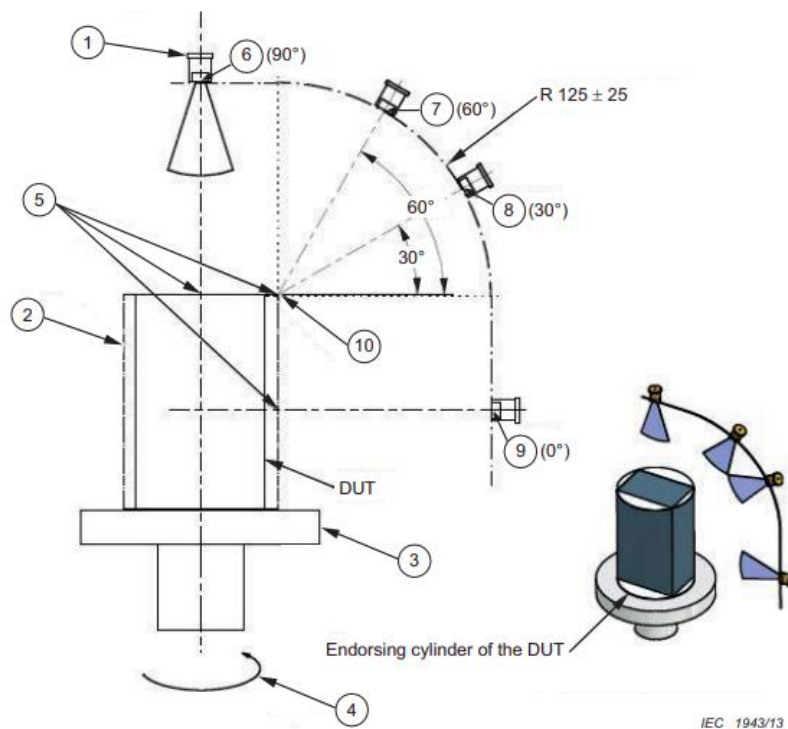
- DUT was placed on turntable that rotates 5 ± 1 r/min
- DUT was sprayed from 4 directions: 0° , 30° , 60° and 90°
- Spraying time: 30 s / direction
- Water flow: 15 ± 1 l/min
- Water temperature: 80 ± 5 °C
- The test setup is shown in Figure 1

| 1 | fan jet nozzle | 6 | position 1 of the nozzle (90°) |
| 2 | endorsing cylinder for DUT | 7 | position 2 of the nozzle (60°) |
| 3 | holder (rotating table) | 8 | position 3 of the nozzle (30°) |
| 4 | swivel axis (axis of rotation) | 9 | position 4 of the nozzle (0°) |
| 5 | reference point for 0° , for 30° and 60° , then for 90° versus the endorsing cylinder for DUT | 10 | centre point of circle R125 mm to locate nozzles |

Figure 1. IPX9 test setup.

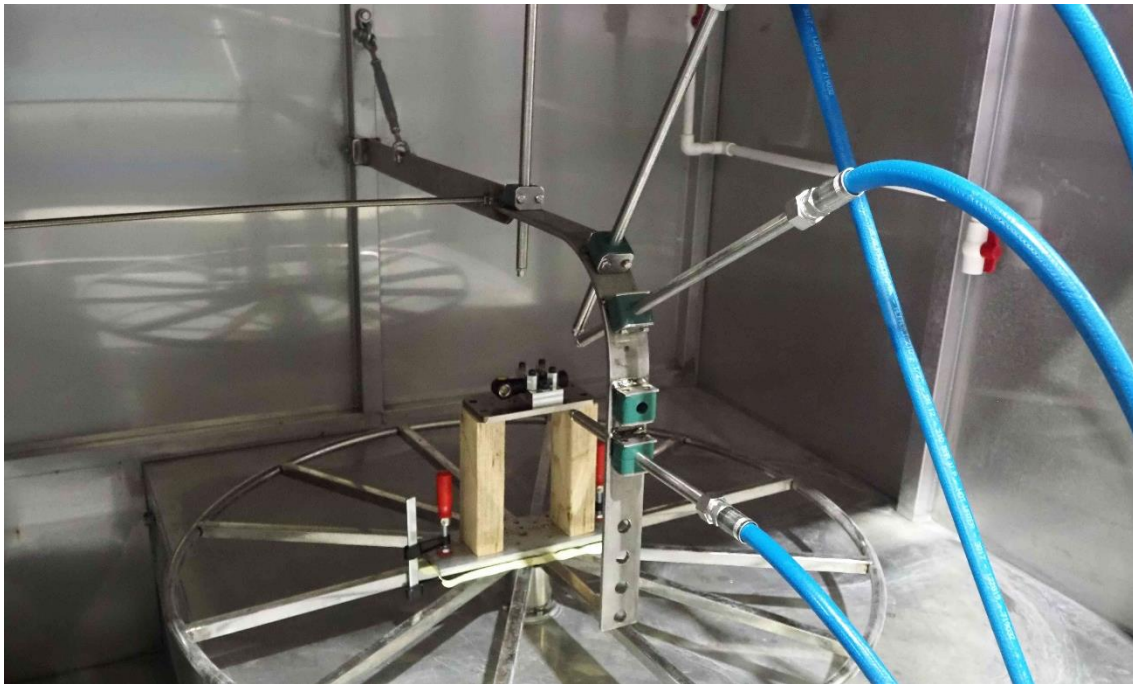
Water flow was maintained between 14-16 l/min and water temperature was maintained between 75-85 °C. Rotating table speed was adjusted to 4-6 r/min. The EUT was assembled on a rotating table and the test was started.

Figure 2. IPX9 test setup.

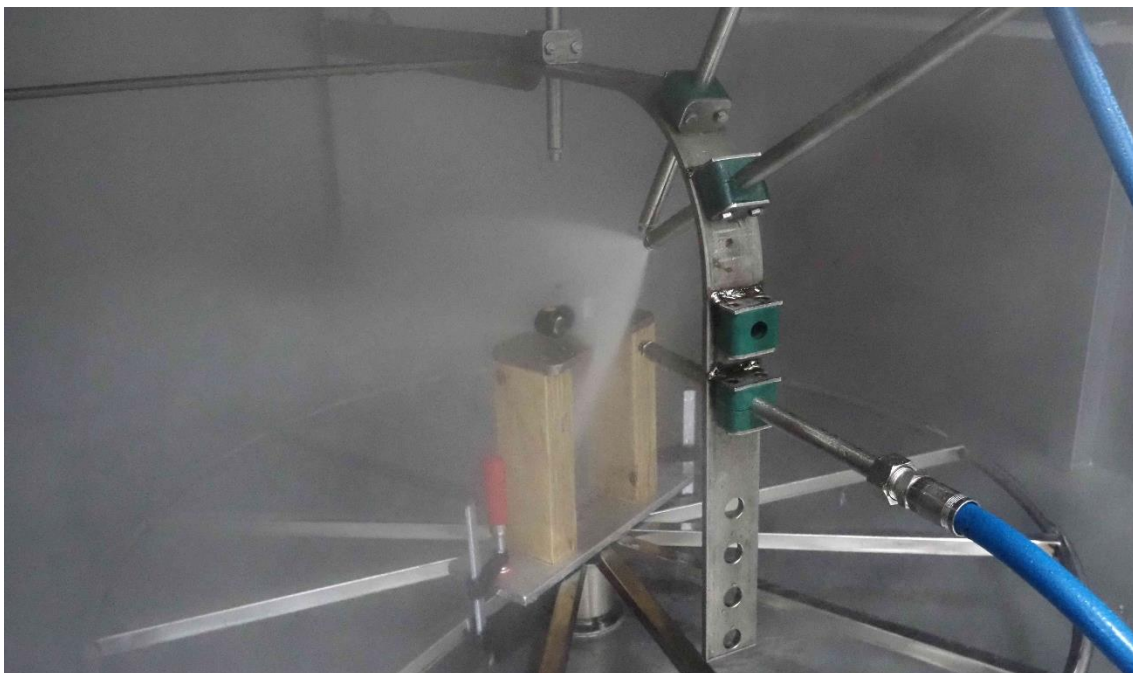
Figure 3. Ongoing IPX9 test.

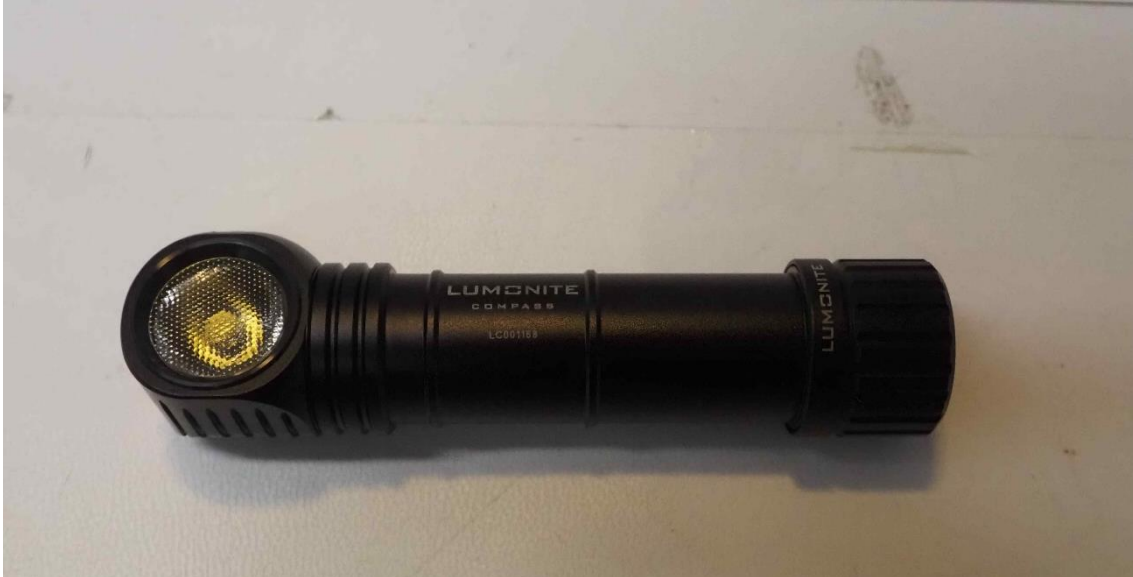
After the test, functionality of the EUT was normal, no water was found inside the battery case and no damage was detected on the EUT's surface.

Figure 4. EUT after the test. No damage was detected.

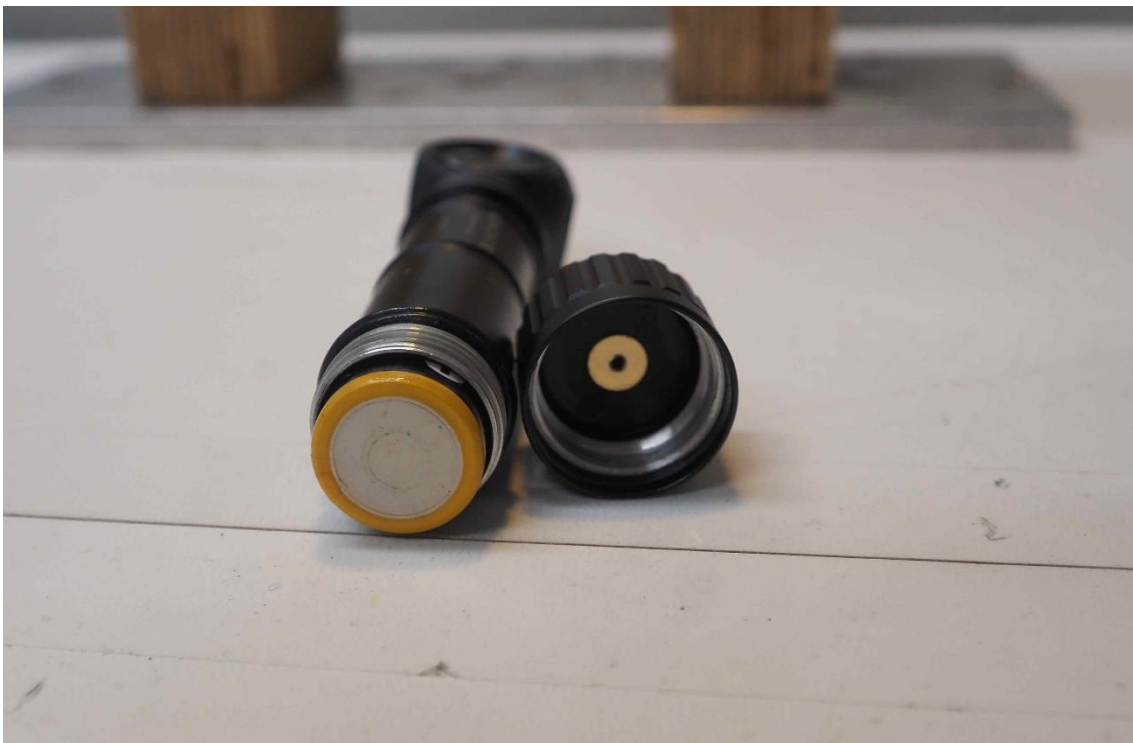
Figure 5. Battery case opened after test. No water was found inside.

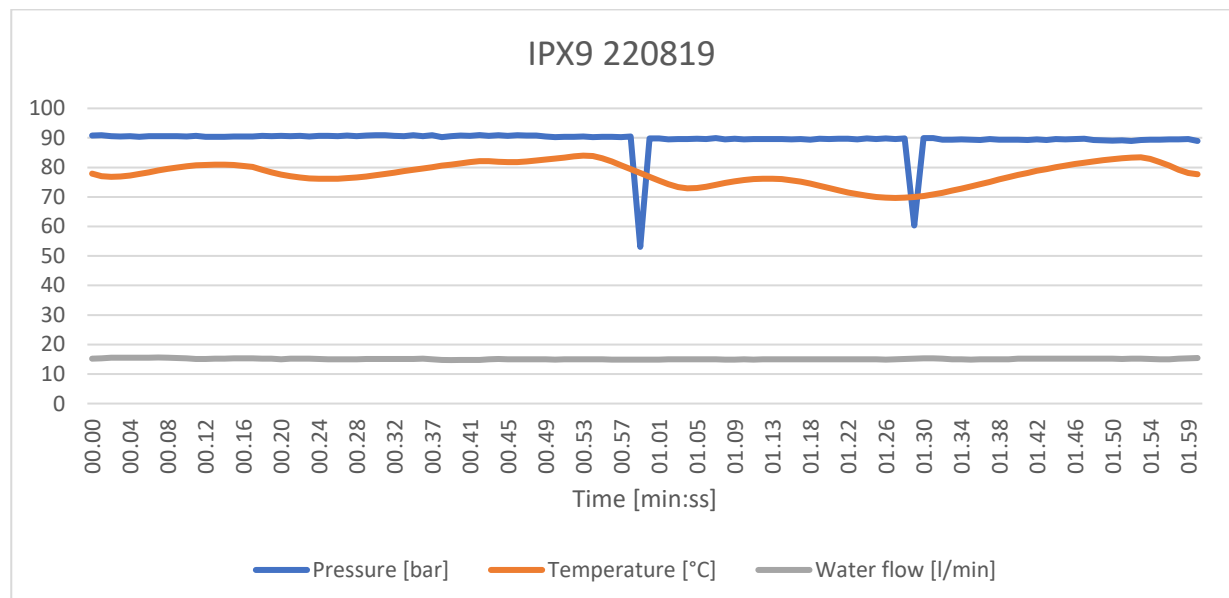
Water pressure, water temperature and water flow measurements are presented in Figure 6.

Figure 6. Measurements during the test.

Due to momentary malfunction of the water heater, the water temperature was below the specified temperature (75 – 85 °C) for a 19 second period. At lowest the water temperature was 69,6 °C.
