TEST REPORT

**“MIL-STD-810H, METHOD 516.8 SHOCK,
PROCEDURE I”**

Lumonite Compass (V7)

Test ID: Shock_Handshake_Compass_2021-06-01
Report version: 1.1
Class: Cust

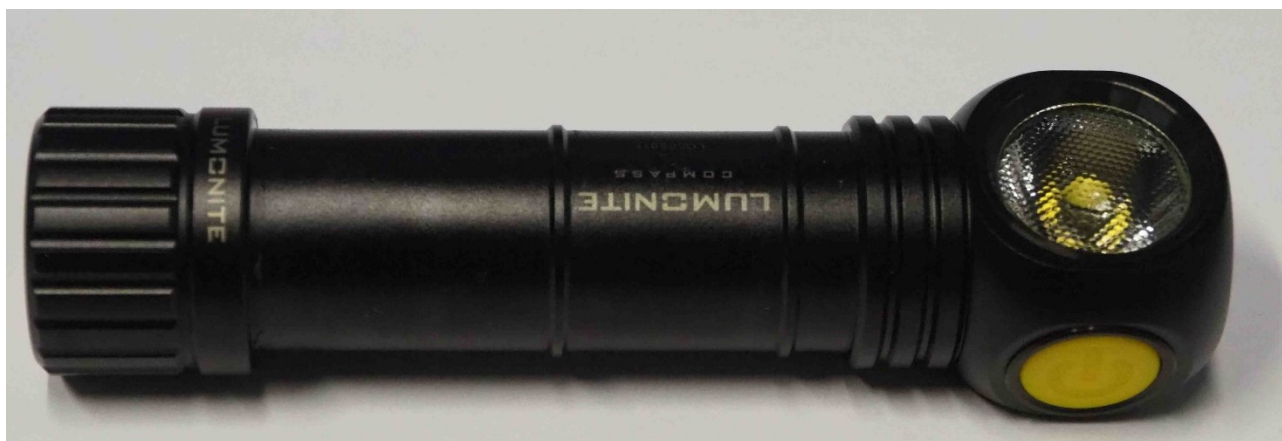
- Lumonite Compass
 - Version: V7
 - Device ID: LC000011

Figure 1. EUT

Equipment Under Test (EUT) Figure 1:
