**TEST REPORT**

**MIL-STD-810H, Method 503.7 Temperature Shock**

Customer: Handshake Finland Oy  
Test name: MIL-STD 810H, Method 503.7 Temperature Shock  
EUT: Lumonite Compass (V7)

Lumonite Compass (V7), Multifunctional High Power Headlamp

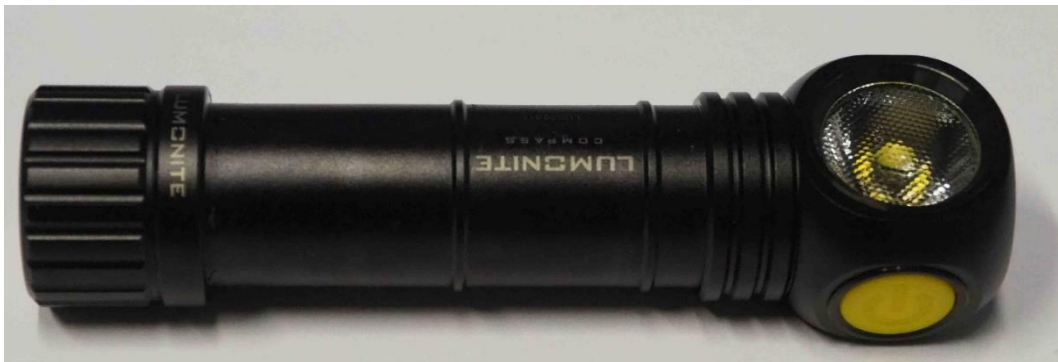
Figure 1. EUT

- 1 pcs Lumonite Compass
  - Version: V7
  - Device ID: LC000013

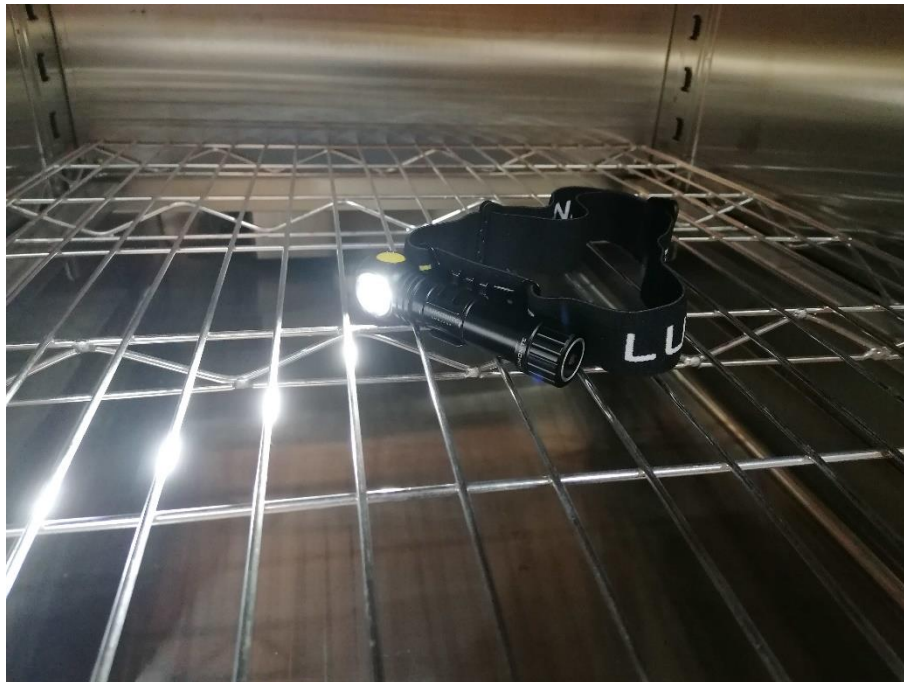
EUT was placed into a temperature chamber and the temperature was changed to -40 degrees in 21 minutes. EUT was 30 min in cold chamber. Then temperature cycling was started in +40 °C test chamber. After 30 min the EUT was manually transferred into -40 °C test chamber to 30 min. Transfer time between the chambers was ≈30 seconds. Three cycles were performed. Then temperature was changed to room ambient to 21 min.

**Figure 3. The EUT in cold test chamber.**

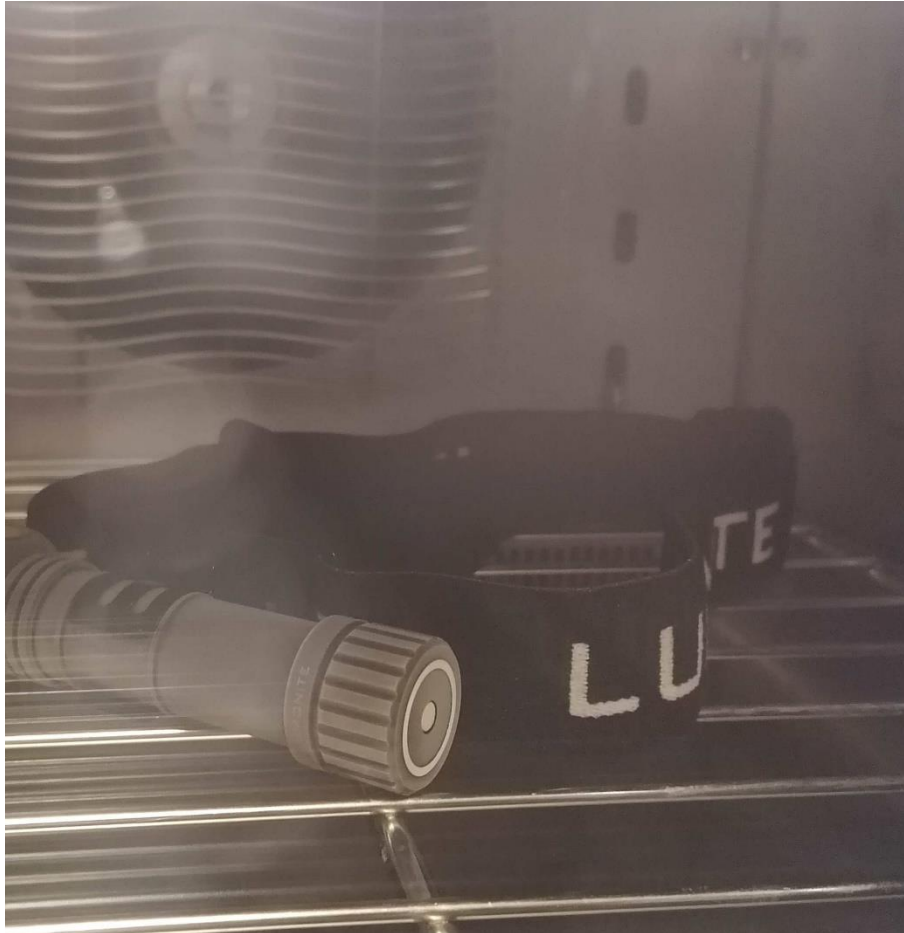
**Figure 4. EUT moved to hot temperature chamber and frosting was seen on EUT's surface.**

In hot temperature periods the EUT's light was set to low power mode. In start of cold temperature periods the light was switched to high power mode. After 15 minutes in cold temperature the light turned off. After every cold period, the EUT was turned on by pushing the power button.

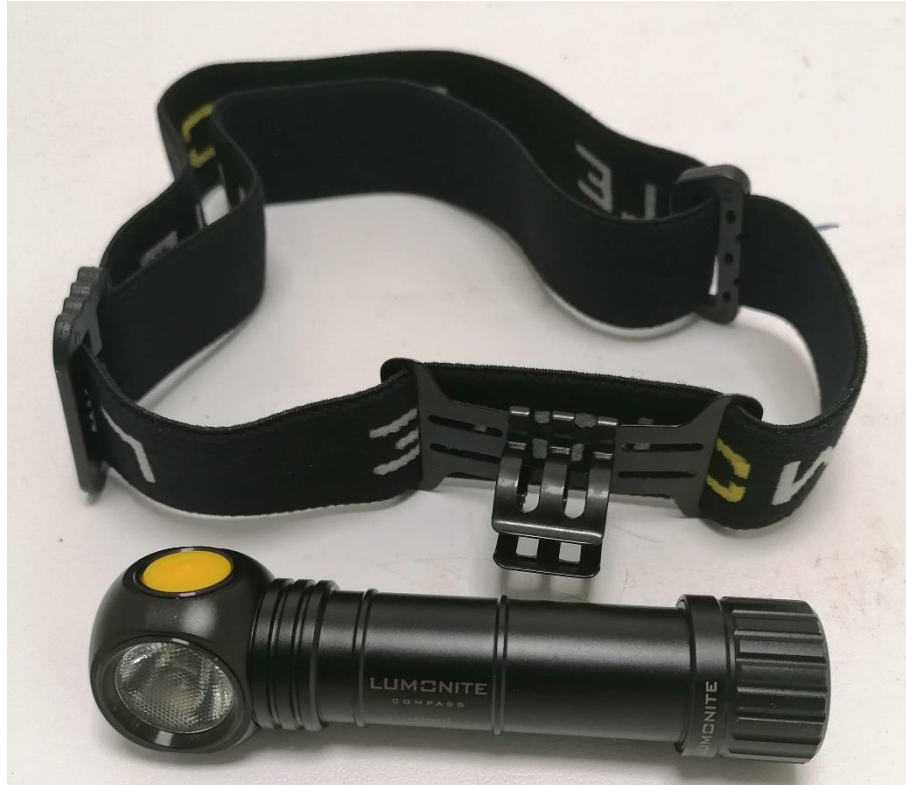
The EUT was functional after the test. No visual change or physical damages were found after test.

Figure 5. EUT after test. No visual change was found after test.

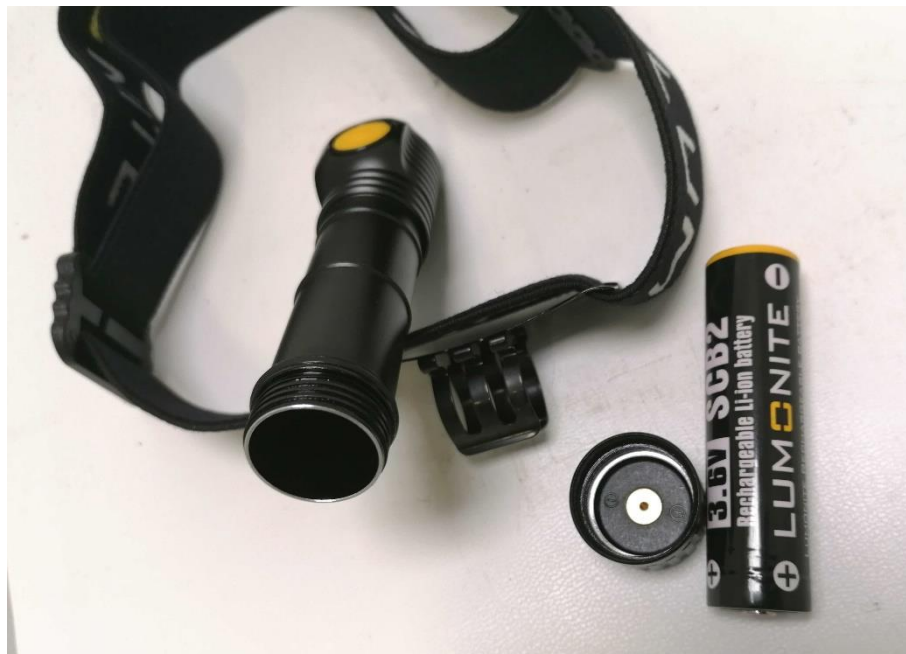
Figure 6. EUT after test. No physical damage was found after test.

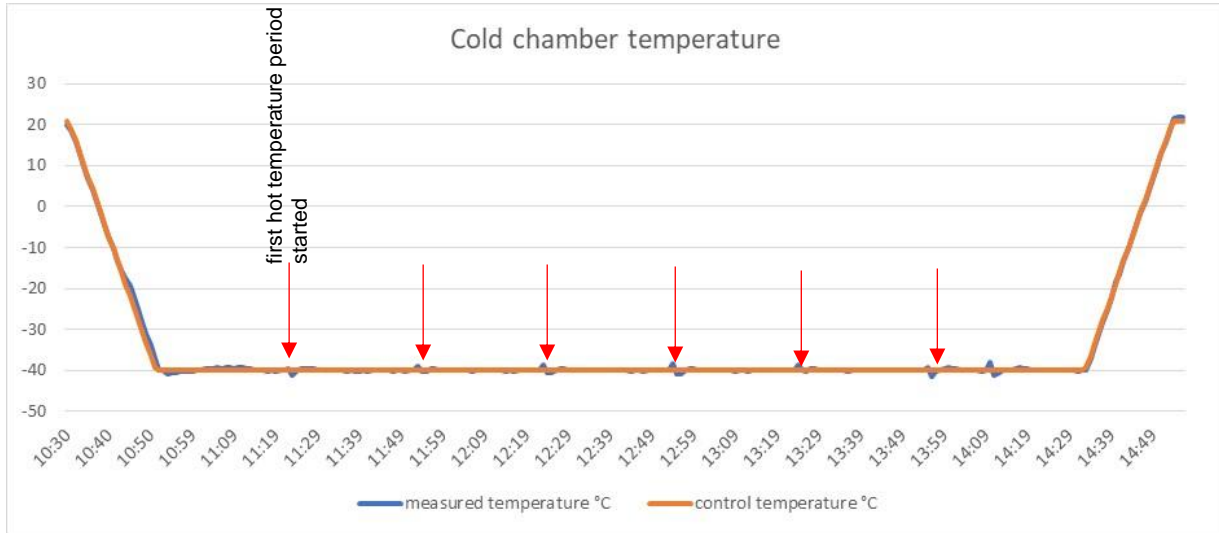
Environmental chamber Espec EGNX12-4CWL, sn. 179705, calibration date is 10.9.2020, calibration valid until 12.3.2022. The environmental chamber calibration interval is 12-18 months.

**Figure 7. Cold temperature chamber curve with transfer time (red arrows)**

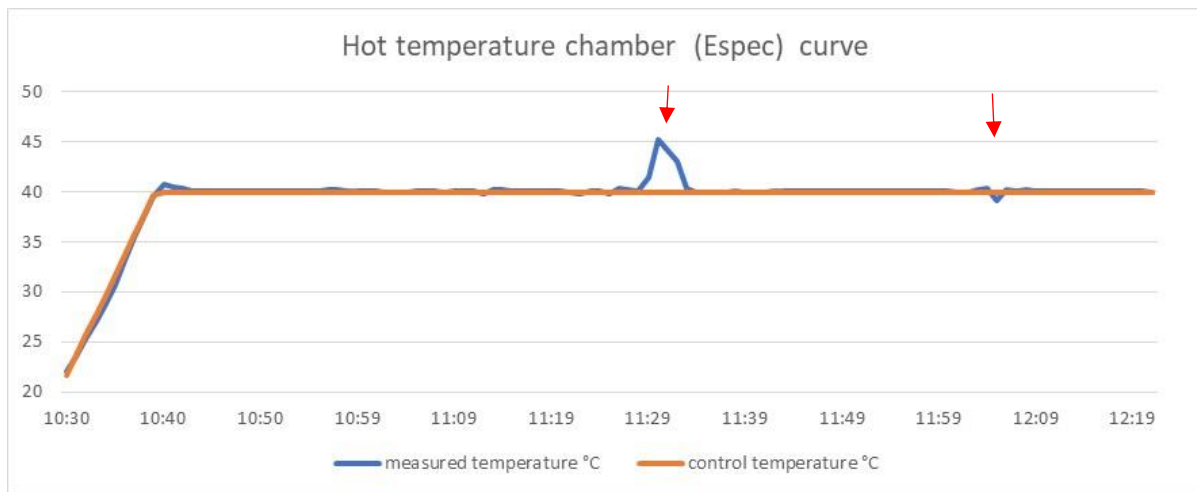
Environmental chamber Espec SH-614, sn. 92006522, calibration date is 18.8.2020, calibration valid until 17.2.2022. The environmental chamber calibration interval is 12-18 months (first cycle)

**Figure 8. Hot temperature chamber curve (Especc) with transfer time (red arrows), first hot period**
