TEST REPORT

MIL-STD-810G 509.6 SALT FOG

Purelux Road Curve C550

CUSTOMER: Handshake Finland
TEST NAME: MIL-STD-810G 509.6 Salt fog
TEST DATE: October 31. – November 4. 2022
TEST SITE: Toptester Oy, Rovaniemi

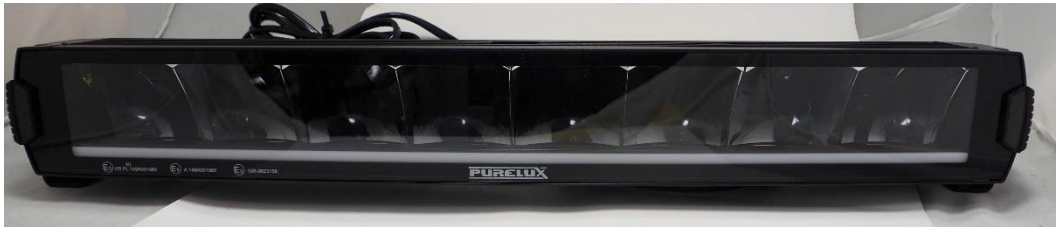
Figure 1. The Purelux Road Curve C550.

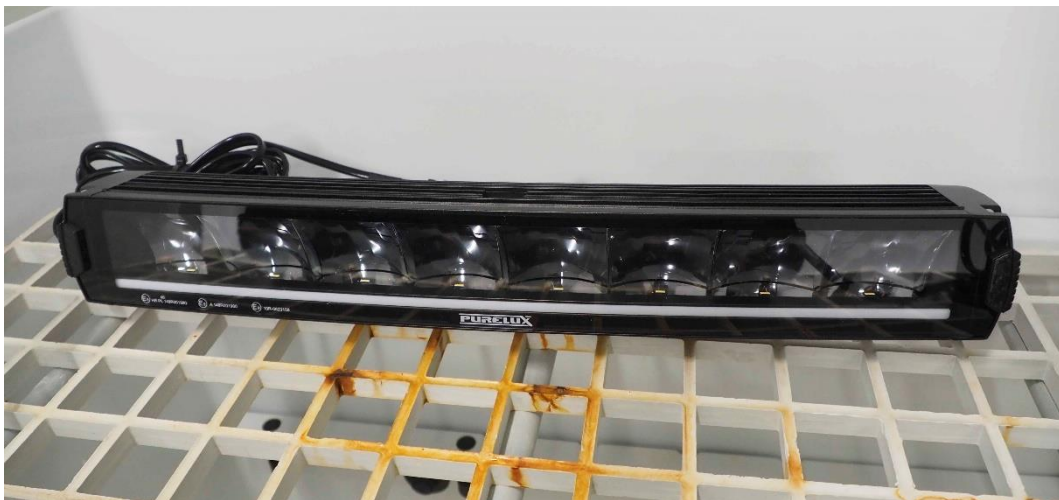
In the first half of the cycle the EUT was placed in the salt mist chamber for 24 hours. The test parameters were set according to MIL-STD 810G, Method 509.6 Salt fog.

Figure 2. The EUT in salt mist chamber.

- Salt mist test chamber temperature was $35\text{ °C} \pm 2\text{ °C}$.
- Salt mist solution was prepared by dissolving $50\text{ g} \pm 5\text{ g}$ sodium chloride (NaCl) to amount of 1 l of demineralized water.
- pH-value of the salt solution was between 6.5 – 7.2
- fall out rate 1-3 ml/hour
- 2x 24-hour period of salt fog exposure and 24-hours drying conditions (at standard ambient temperature and a relative humidity of less than 50 %)

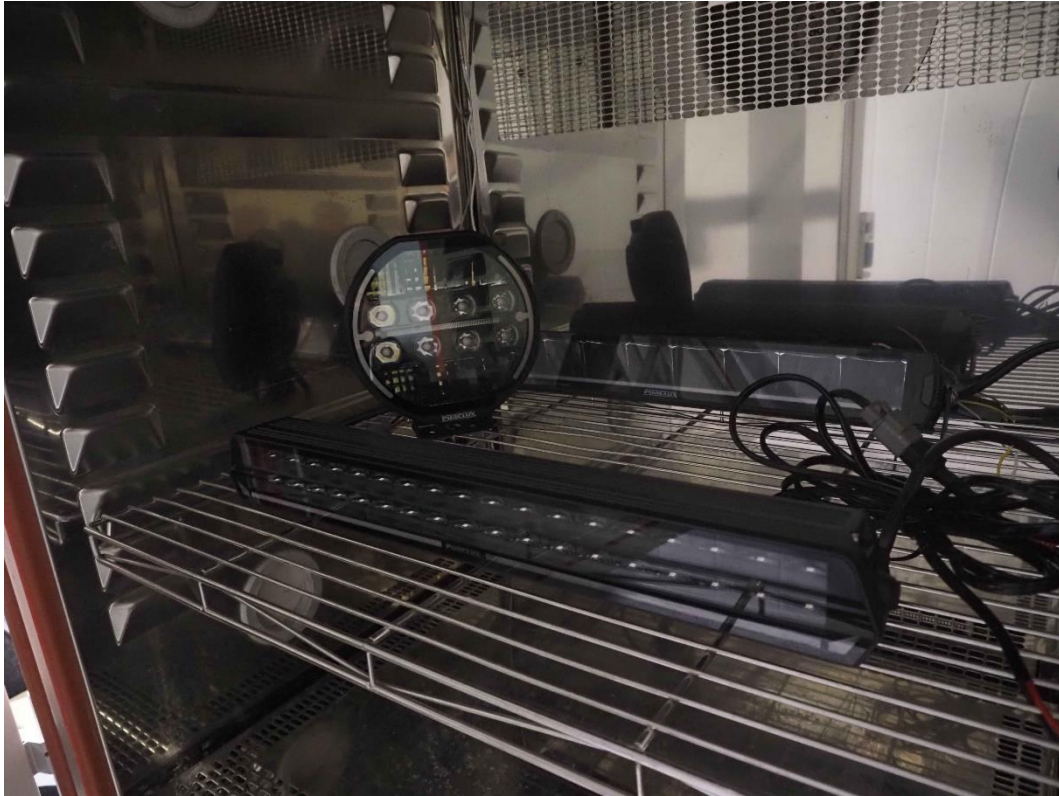
After 24 hours the EUT was removed from the chamber and placed inside an environmental chamber for 24 hours for the drying sequence. This cycle was repeated twice. The test setups for the complete cycle can be seen in Figure 2. and Figure 3.

Figure 3. The EUT in environmental chamber.

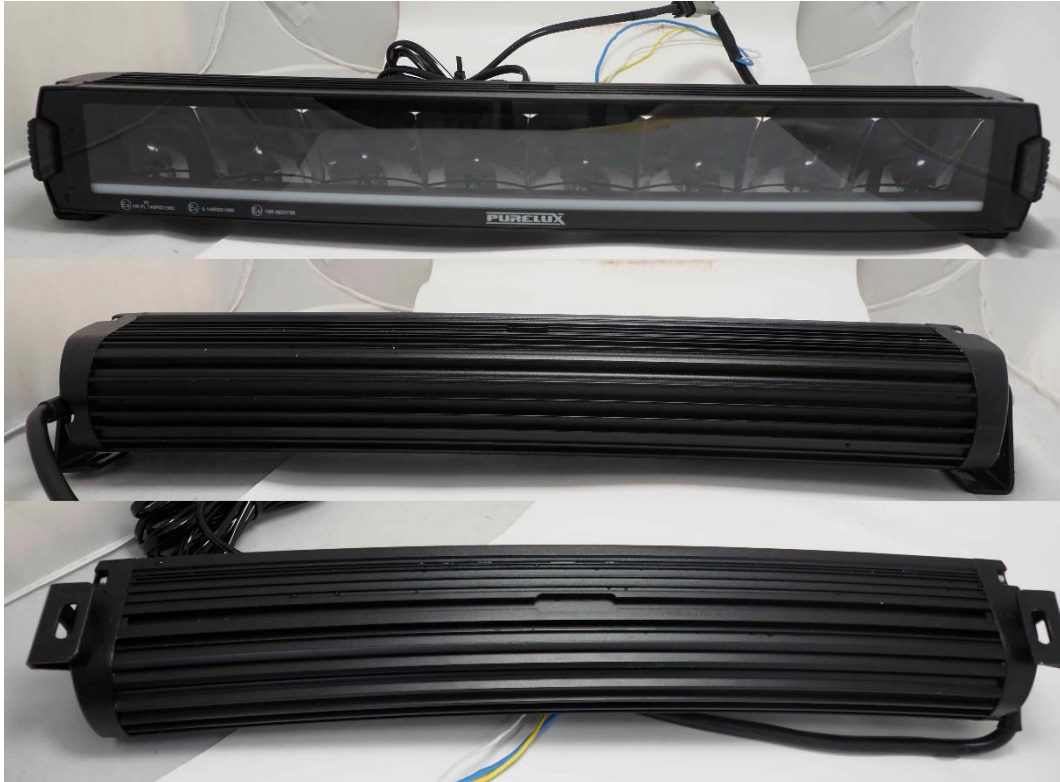
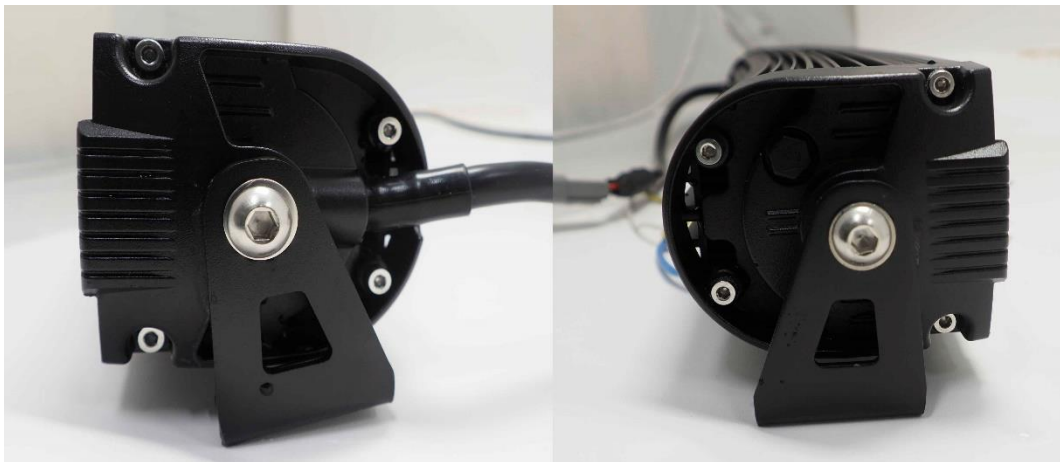
After the test the EUT was rinsed and cleaned from salt residue and dried.
The EUT was inspected after the test.
No problems in mechanical integrity were seen and the functionality was the similar before, and after the test.

Figure 4. The Purelux Road Curve C550 after test.

Figure 5. The Purelux Road Curve C550 after test.

EUT was functioning normally after the test. No mechanical or chemical failures were found from the surface of the Purelux Road Curve C550.

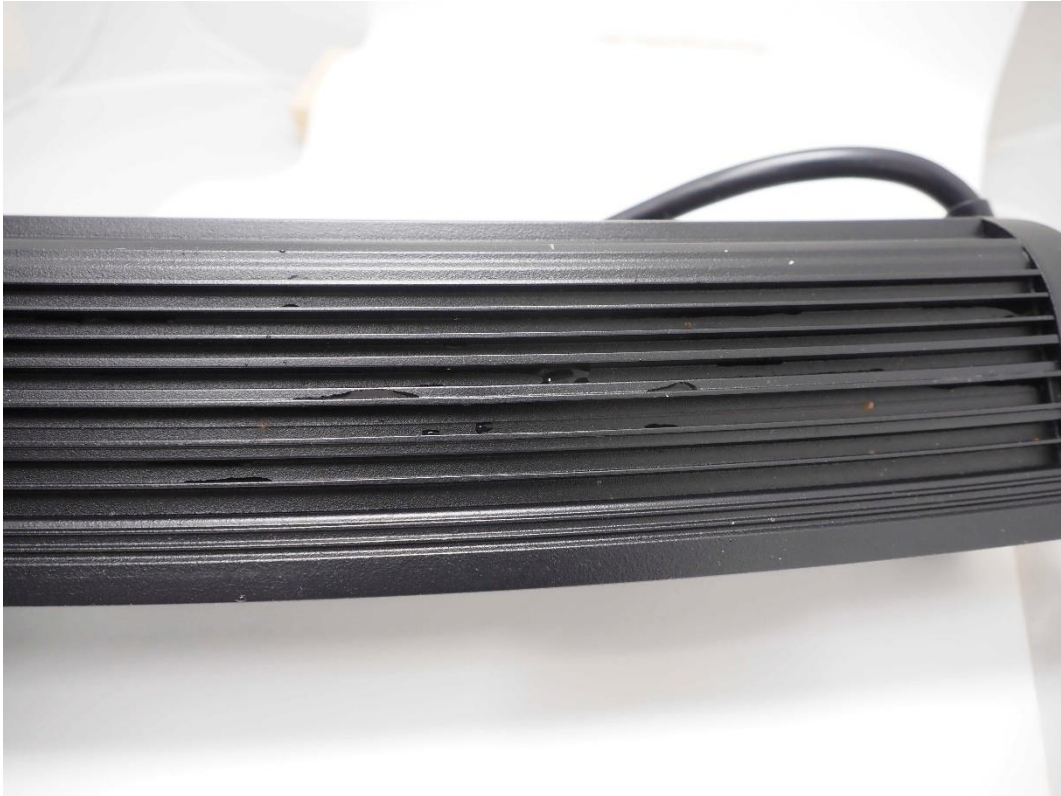
A small spot of corrosion was found from a surface of the EUT. The surface is aluminum which does not form this kind of corrosion. The corrosion spot can be caused by metal particles stuck to the surface.

Figure 6. A small spot of corrosion was found from the EUT after test.
