TEST REPORT

TEST NAME: MIL-STD-810H, METHOD 503.7, TEMPERATURE SHOCK

DEVICE NAME: COMPASS R
VERSION NR: COMPASS R (V.6)
DEVICE ID: 6078

Test id: Env_ Hanshake_201028_01

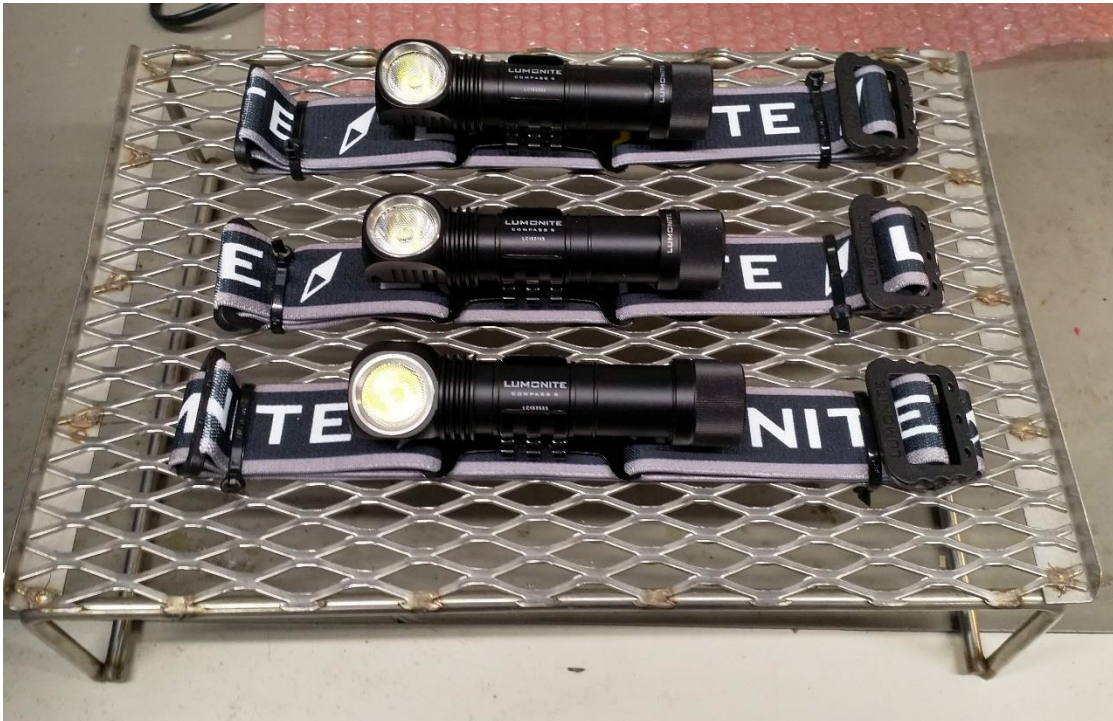
Picture 1. Compass R headlamps on test tray

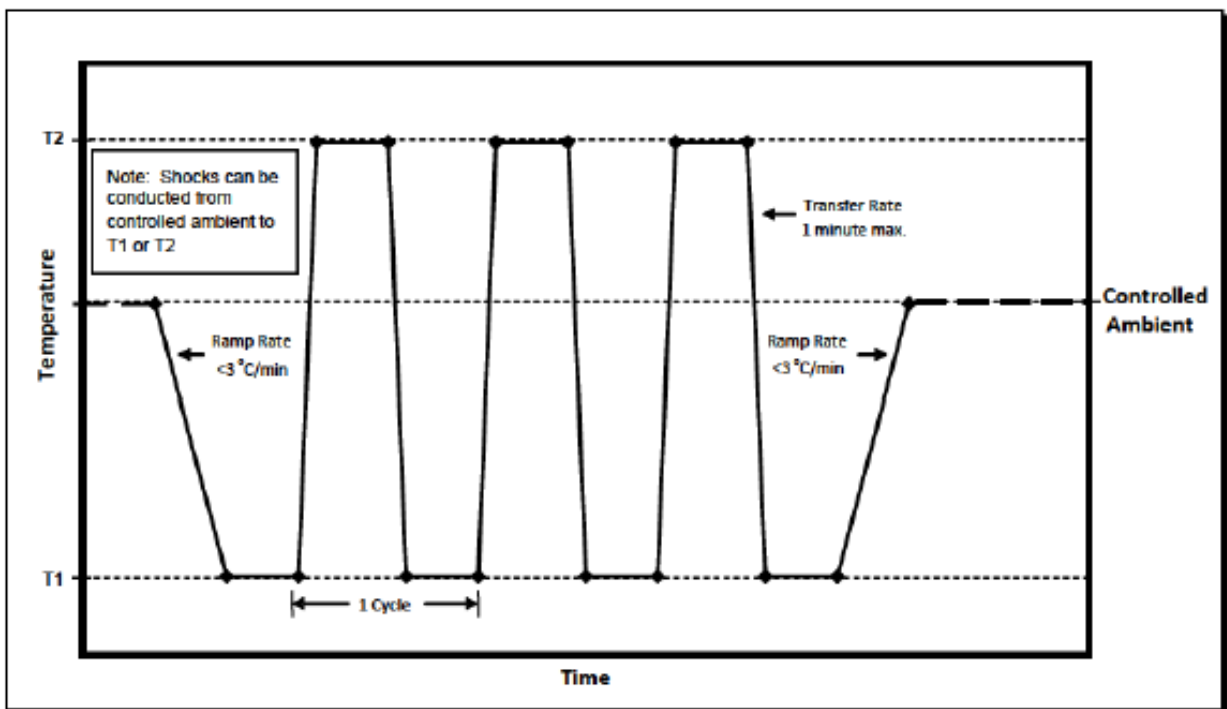
The test performed was MIL-STD-810H, Method 503.7, temperature shock, Procedure I-C (Multi -cycle shocks from constant extreme temperature). Test dwell temperatures were -30°C and +40°C. One cycle contained 30 min dwell in each temperature and less than one minute transfer time between temperatures (chambers). Three cycles were performed.

Picture 2. Multi-cycle shocks

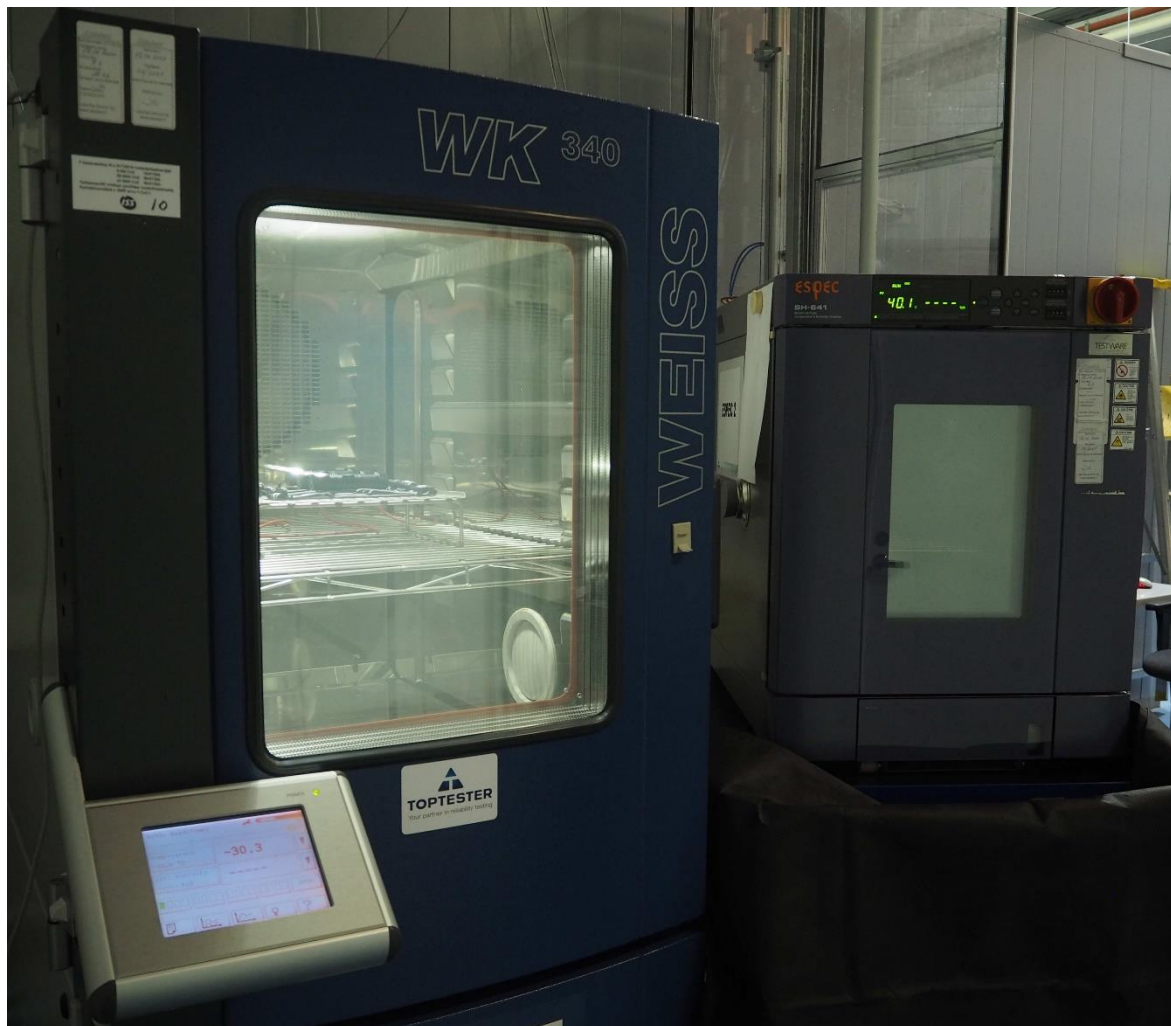
Picture 3. EUTs on cold temperature chamber and elevated temperature chamber

EUTs were inspected and installed on metal tray. EUTs power level was adjusted to medium. Metal tray was placed inside of Weiss environmental chamber and chamber control program was started. Espec environmental chamber was heated to elevated test temperature. After 30 min soak on time at -30°C temperature, EUTs were transferred to elevated temperature chamber (40°C) for 30 min soak on time. This procedure was repeated three (3) times.

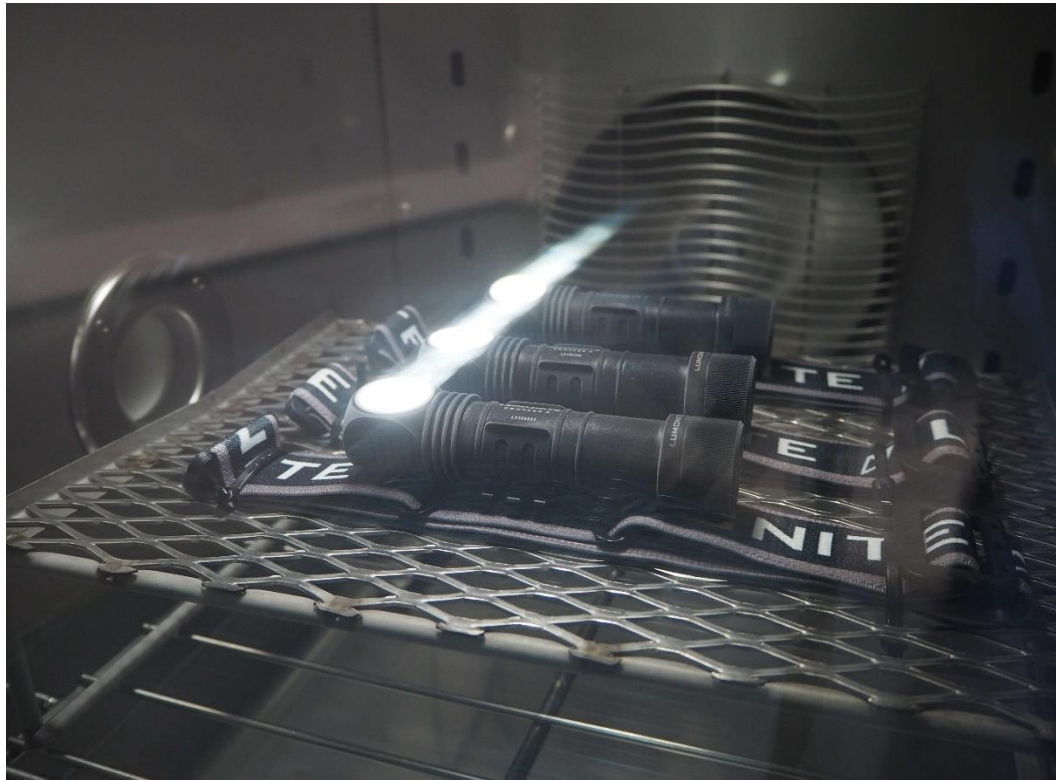
Picture 4. EUTs moved to elevated temperature chamber and frosting was seen on EUT's external surfaces

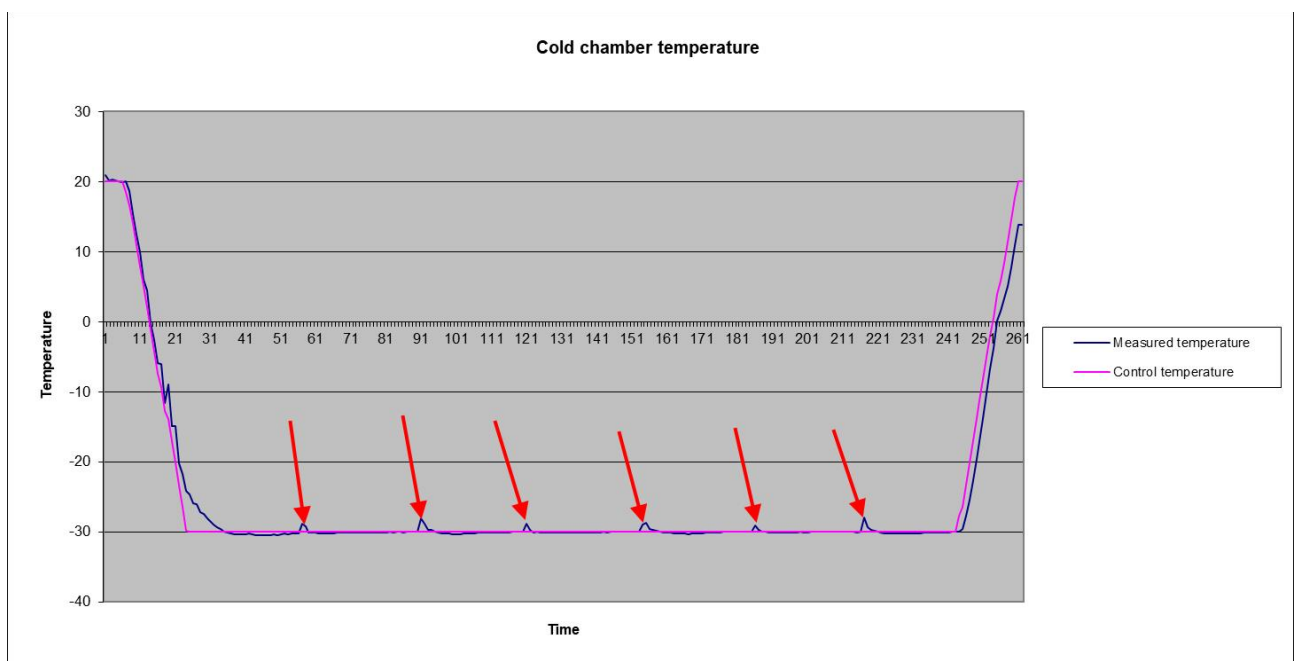
Picture 5. Cold temperature chamber curve with transfer timings (red arrows)

After the last transfer and 30 min soak in cold chamber, the chamber temperature was gradually heated to controlled ambient temperature.
